Case Study

Landuse Suitability and Infrastructure Assessment Gaza Province Mozambique

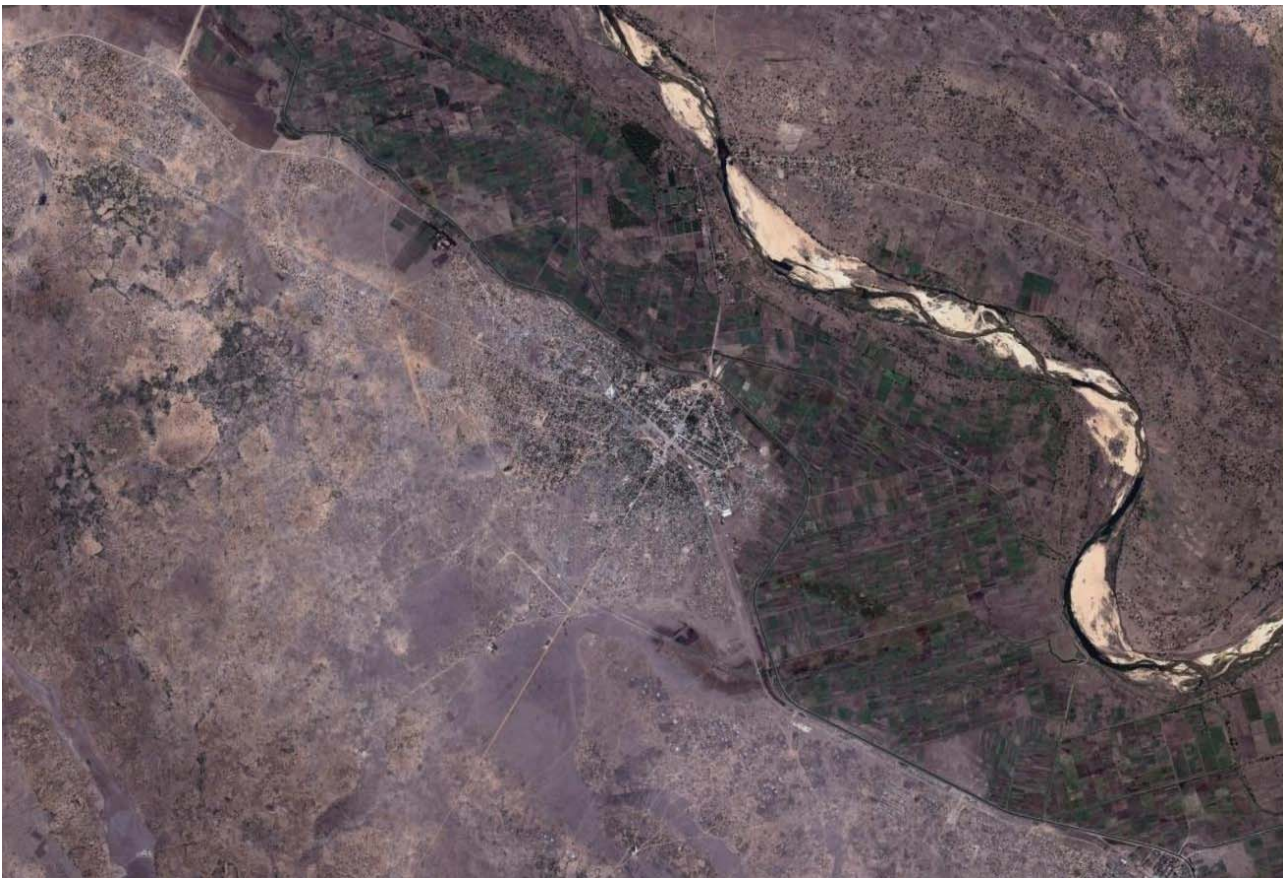
Fig.1 : Irrigation development - Gaza Province, Southern Mozambique

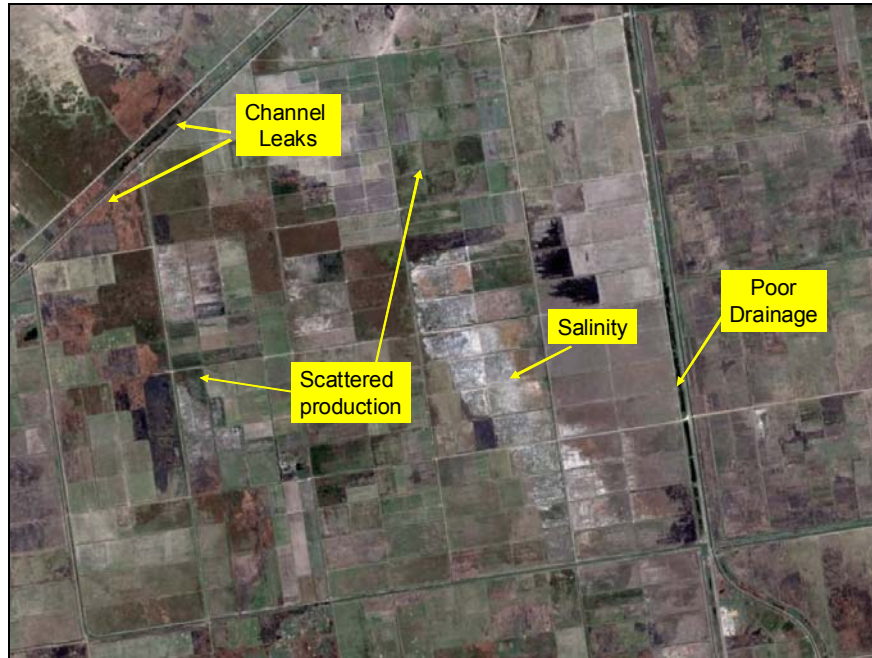
Initial investigations of available satellite imagery defined the geography of the study area, provided excellent background to the existing map and infrastructure information and highlighting a range of issues (fig 2-3.) not previously apparent to the client from 2 years of ground observations. These included;

- Large areas of apparent salinity
- Impact of poor channel management
- Isolated nature of existing production
- The extent of abandoned irrigated area

Fig.2 : Existing irrigation area management issues

2. Existing salinity is likely to have been caused by previous and current irrigation system management in relation to fields, supply and drainage infrastructure. Cleaning of all channels to remove excessive weed growth and improved drainage water management is required to address the salinity issues.

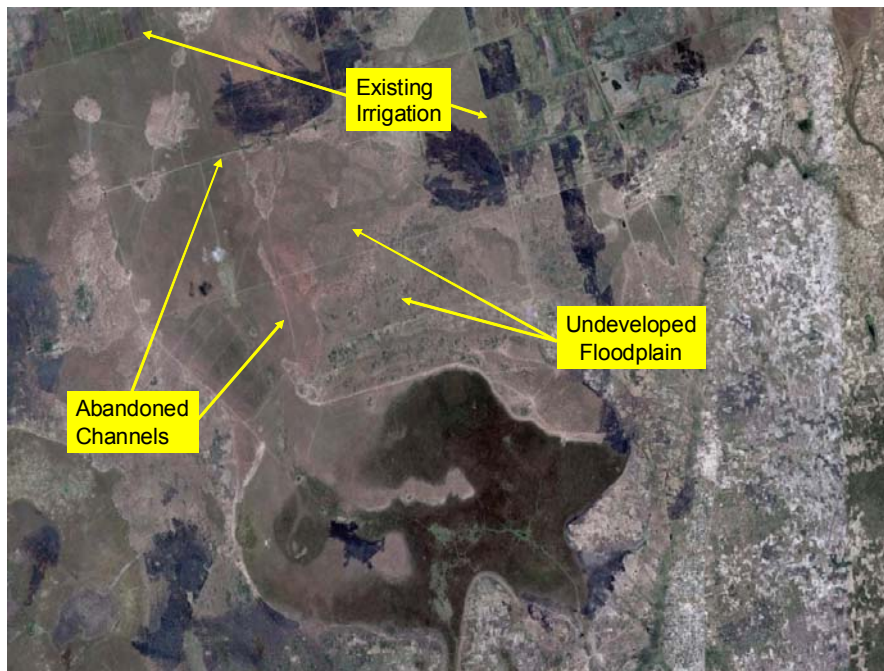
Fig.3 :Proposed irrigation development area issues.

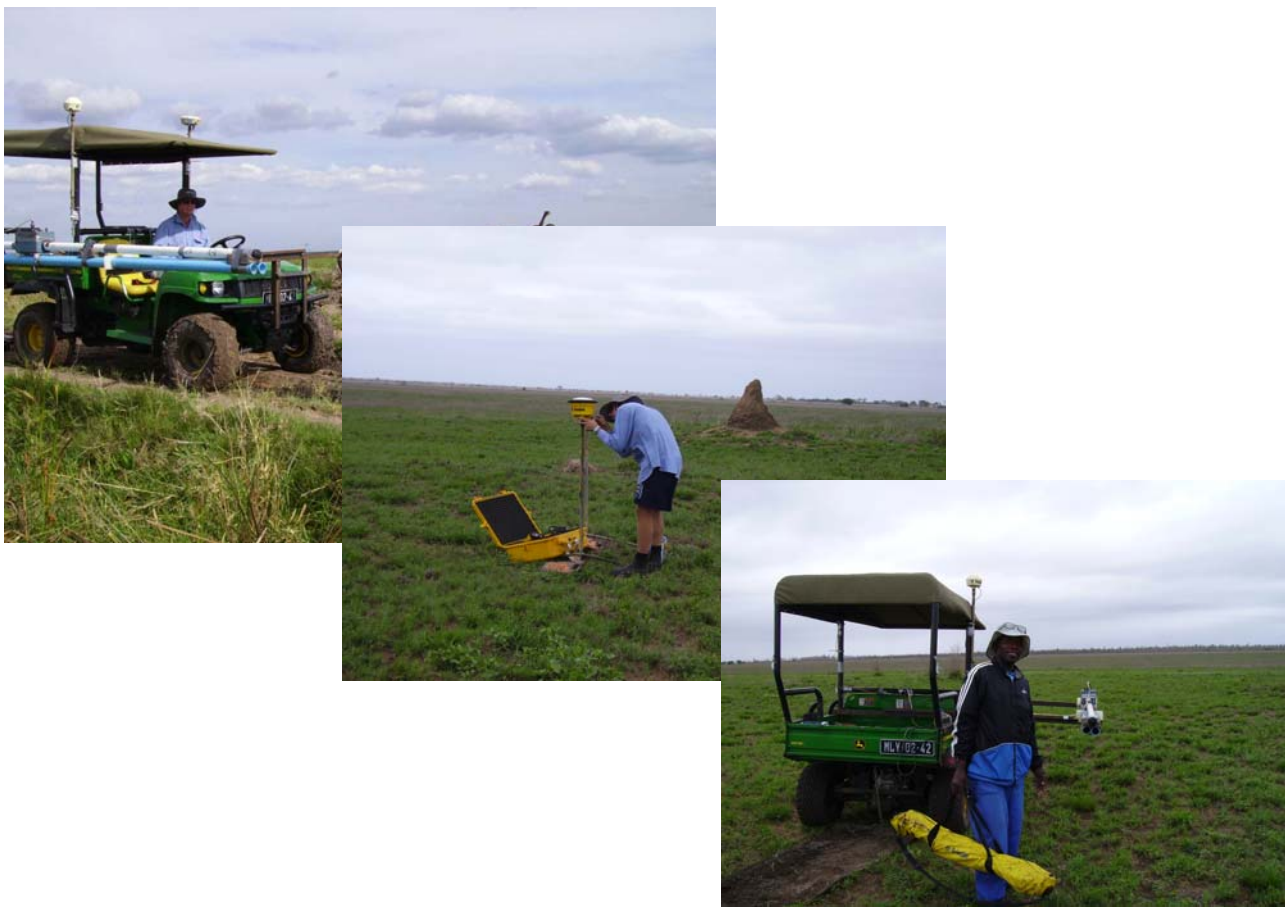
Following assessment of the satellite imagery and collated background information, a detailed soil conductivity and topographic survey was conducted using two electromagnetic induction instruments (Geonics EM31 and EM38) and high accuracy GPS equipment.

The instruments are mounted on a 4WD bike or vehicle (fig 4.) allowing access to all but the roughest and wettest land and measure soil characteristics to a depth of 6 metres.

Fig.4 : Electromagnetic induction instruments and RTK GPS mounted on a four wheeled bike

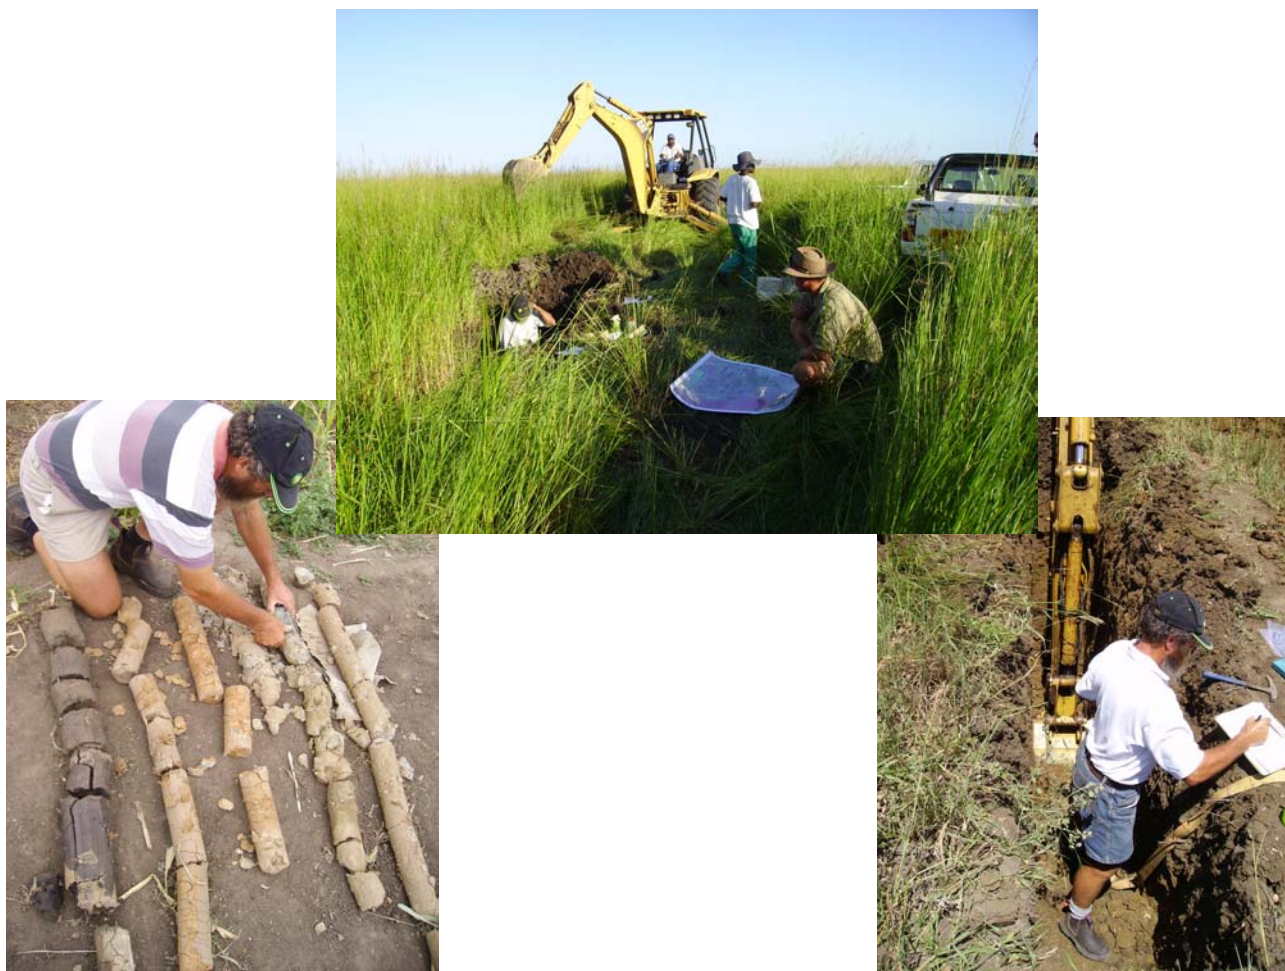
The targeted soil profile investigation plan was developed to initially determine the magnitude of difference between the highest, lowest and average conductivity locations, and correlate soil conditions and soil conductivity, from this further sampling is determined as required. Additionally, these investigations identified soil conditions at the time of surveying. Initial fieldwork (fig 6.) involved both physical soil description with samples retained for chemical assessment.

Fig.6 : Detailed soil investigations conducted at locations based on the apparent conductivity maps
